TECHNICAL ASSISTANCE IN CONNECTION WITH TEKTITE I

DEPARTMENT OF THE NAVY

August 20, 1969

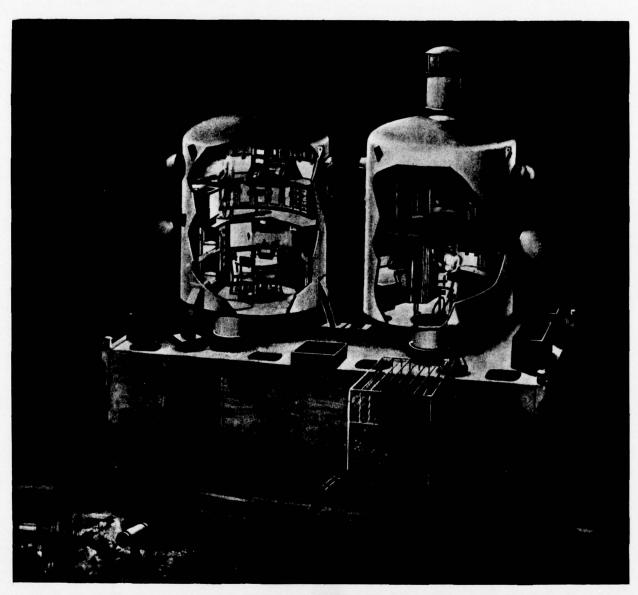
FIGURE 1. CROSS-SECTION VIEW OF TEKTITE I HABITAT

The habitat as a whole provided a comfortable and very livable home for long-duration, shallow-water, saturation dives (see Figure 1). As a laboratory it was not optimum, but adequate. A number of small problems occurred, some caused by human error and some by design or equipment faults, most of which required remedial action and some of which caused a large degree of concern. In pointing out problems and faults, it must be borne in mind that the majority of equipment functioned as designed and that the design success of most aspects of the habitat provided major contribution to the overall success of the program.

The basic structural design of the habitat was good. The brightness of the paint clouded somewhat with marine growth over the 60-day duration, but no significant external corrosion was noticed. However, paint and primer flaked off the deck in the wet room, allowing rust to form on the exposed steel. This rust and paint falling into the bilge clogged the strainer to the bilge pump and thus restricted water removal. The problem can be eliminated by priming and painting the decks well in advance of mission start.

It was noticed that water collected in puddles behind the sinks in both the engine room and the wet room and the cabinet doors swung open in the same sloping direction both in the crew's quarters and in the wet room. It may be that the habitat was not level on the ocean bottom. Even though the bottom was leveled by the Seabees prior to emplacement, over the 74-day time the habitat was on the bottom, the habitat may have settled. This is not particularly important to habitation; however, if the emergency hatch in the crew's quarters is only 1/2 foot higher than the hatch in the wet room, a force of about 450 pounds is necessary to overcome the pressure on the emergency hatch. Of course the reverse could occur too. Fortunately, it was not necessary to use this hatch. Mechanical leveling legs could be installed to level the habitat and an internal needle valve in the escape hatch could quickly equalize any other pressure differentials.

The crossover tunnel held up well as a structural item. The four pinhole leaks noticed in the beginning of the mission gave no trouble. However these should be repaired for future missions. In addition, inconvenience in using the tunnel was noted. The occupants must duck walk or crawl through the tunnel many times a day. Since, functionally, it proved effective, the problem of crossing is a matter for personal adaptation.

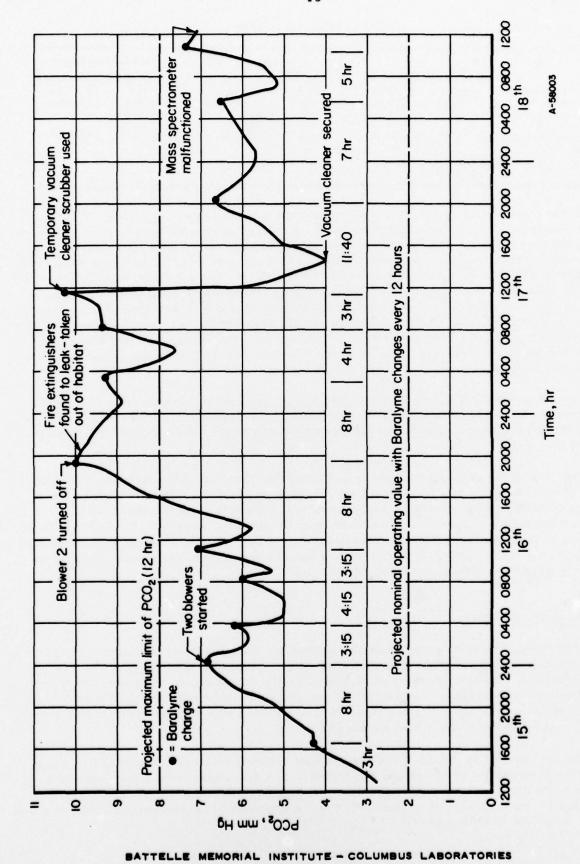
FIGURE 2. GRAPH OF CO₂ SCRUBBING UNTIL FAILURE OF THE MASS SPECTROMETER

Three days into the mission the mass spectrometer malfunctioned. The fault was determined to be an overheated transformer. It was disassembled into two parts by the aquanauts and sent topside for repairs. The fact that this complicated instrument could be taken apart, sent up, and reinstalled is significant not only to underwater research, but also to space exploration. If equipment is even partially serviceable by inexperienced researchers in isolation, then astronauts can perform similar work under analogous space conditions.

The mass spectrometer malfunctioned again on the 46th mission day. This time the fault was attributed to failure of the ion pump. It remained out of service for the duration of the program. The mass spectrometer was down for 25 days of the 60-day mission.

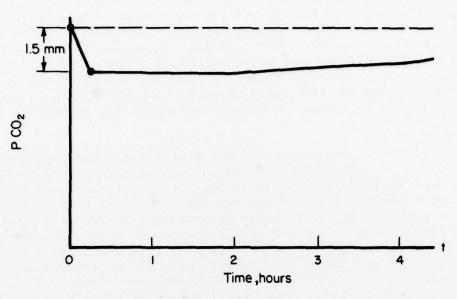
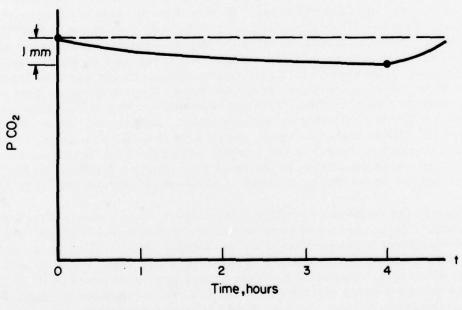
On March 1, 1969, an auxiliary scrubber from the U. S. Navy Experimental Diving Unit was installed in the engine room. Later in the program a scrubber from Duke University replaced the EDU scrubber. These helped to keep the CO₂ level in check, allowing longer time periods between Baralyme changes for primary mission research. A comparison, made by the aquanauts on the 17th day, of the effectiveness of the ECS scrubber and the EDU scrubber is shown in Figure 3. Both scrubbers use a 15-pound absorbent charge, but the EDU scrubber quickly reduced the CO₂ level to 1.5 mm Hg, while the ECS scrubber gradually lowered the level only to 1.0 mm Hg.

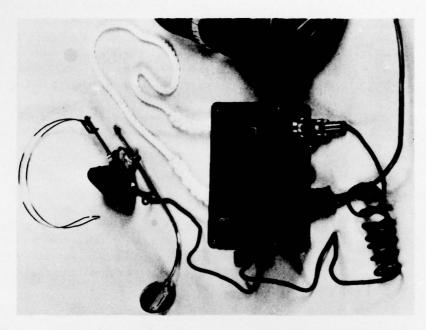
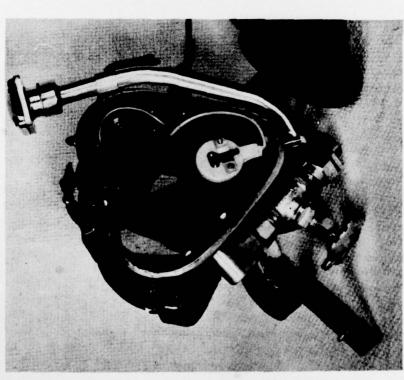
FIGURE 4. JACK BROWN FULL-FACE MASK WITH COMMUNICATIONS

The mask and communications worked well throughout the duration of the program, but the hookah system could be made more convenient to use. In Tektite I, the hookah hose was attached to the low-pressure-air source in the habitat, routed through the 10-inch truck from the wet room, and coiled on makeshift chocks outside the shark cage; then the mask was brought back into the wet room through a crack in the shark cage door and hung on a bracket for the aquanaut's use. The hose leading through the shark cage and wet-room trunk was fastened to the screening by short pieces of coated wire to keep it out of the way of swimmer traffic. For follow-on missions, the hookah could either be coiled and stored inside the wet room or be wound on a reel outside the shark cage with cleats to hold the hose to the side wall. Either of these methods would make the hookah more convenient to use.

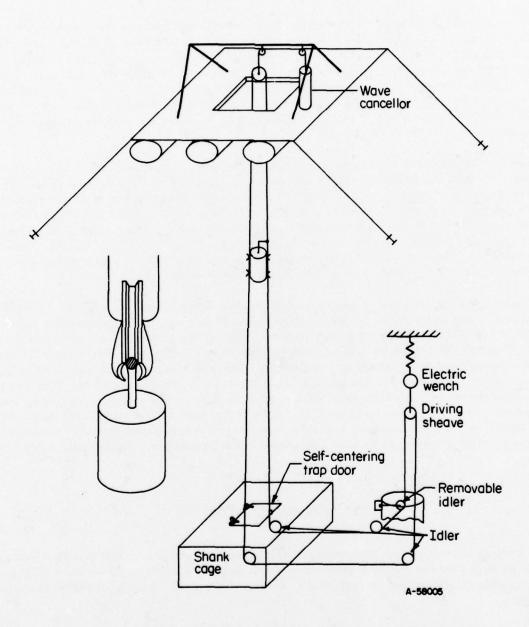
FIGURE 5. DUMBWAITER-SYSTEM CONCEPT

The large transfer pot, a heavy steel can, was overdesigned for use at 50-foot depths. It was too heavy for convenient handling, and had a tendency to rust. Considerable bottom time and energy was expended in simply transferring materials. Constant maintenance was necessary with each of the steel pots, not only to reduce external rust, but also to clean up sealing surfaces to effect proper seals. Furthermore, many items arrived in the habitat wet or crushed.

It is suggested that new noncorrosive transfer pots be bought or fabricted which are negatively buoyant when loaded. Small lead weights can be used to adjust the buoyancy for light loads. Then, a simple closed-loop dumbwaitering system, such as the one shown in Figure 5, could be used. A wave and tide canceller, nothing more than a counteracting weight sliding in a tube, could be attached to the platform sheave to keep system lines taut. The parallel lines to the habitat serve as guy lines for the pot in transit to and from the habitat. The pot is guided through a self-centering trap door in the top of the shark cage, and is then conveyed, via idlers, into the trunk. Slack is taken out of the lines by the electric winch which also acts as the driving force for pulling in the transfer pot. Idler sheeves could be placed so they are out of the way of entering and exiting divers when the system is not in use. The removable idler is placed in a socket in the trunk to provide clearance between the trunk and the pot when transfers are being made. When the system is not being used, the idler is removed, allowing guy lines to lie out of the way against the trunk walls in cleats.

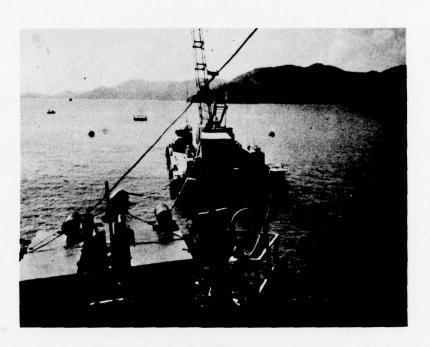
FIGURE 6. SUPPORT BARGE AND CRANE BARGE WITH DECOMPRESSION COMPLEX

The variety of equipment on both the control barge and crane barge (Figure 6) to supply power, gas, water, and monitoring support to the aquanauts functioned very well and allowed few interruptions in service.

The support barge was raised out of the water away from wave action by winching it onto piles in the corner hawse pipes (Figure 6). Since the bottom along the east shore was rocky, the piles were to be held upright by guy wires attached to rock bolts in the bottom. Fourteen holes were drilled underwater in the igneous volcanic rock by the Battelle electric tool for installing rock bolts. Unfortunately the winches used to pull the barge out of the water did not have a capacity equal to the heavy load. The barge was barely out of the water in calm weather and was cocked on the pilings. In heavy weather, the barge was shaken by wave action. In future programs at the Lameshur Bay site, thought could be given to building a stable pier before the mission begins. At other sites, not readily accessible to land, a larger vessel could be used for all support functions.

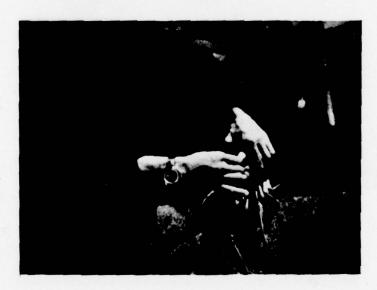
FIGURE 7. LOBSTER DETECTING AND TAGGING DEVICE

feeding cycles, etc., a sonic tag was used (Figure 7). The sonic tags had an effective range of only 50 to 100 feet. Part of this problem may have been the extreme directionality of the receiver, but most of the problem was the low-intensity output of the pinger. For future programs, longer range pinger/receiver sets would be more effective. This is an item for development. The signal can be made stronger or the receiver made more sensitive.

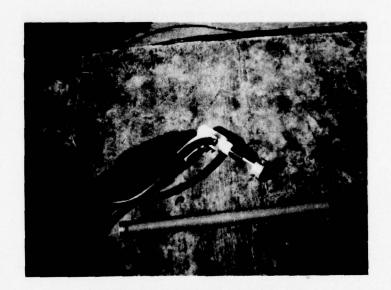
FIGURE 8. CORING TOOLS

Two types of coring tools were supplied to the aquanauts by Battelle's Columbus Laboratories (Figure 8). The first was an electric underwater drill developed by Battelle under contract to the U. S. Navy Supervisor of Salvage. Two 14-inch diamond-tipped core barrels, 3/4 inch in diameter, were supplied with the tool. The electric tool was to be used primarily for taking geological core samples in hard rock and coral. It worked well during training, and halfway through the mission it was used to take rock core samples. During this experiment the diamond tip on the barrel broke off. The spare barrel was located, but the coring tool was not used again. If the tool is to be used on future missions, added protection could be gained by storing it inside the habitat rather than leaving it outside continuously, and to insure continuous good service, it should be thoroughly flushed with fresh water after each use to prevent salt buildup on the rotor.

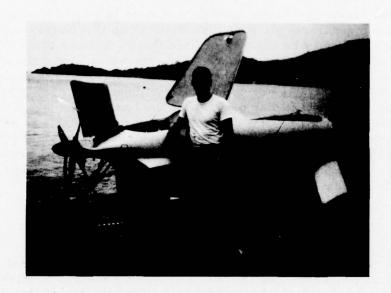
FIGURE 9. MINI SUB

The sub had not been overhauled or evaluated before it arrived on-site. As a result, it was found to be defective in many areas. The original batteries were useless, the oldfashioned floating switch gear for selecting motor speeds was corroded and interconnecting wires were missing, steering linkages were disconnected and the wings were out of adjustment, the variable water ballast tank had a hole in it, the dogs on the stainless steel clutch in the electric motor were broken off, and insufficient Styrofoam buoyancy material was included. The sub had to be completely overhauled from stem to stern before it would be of any use, a difficult task without the proper tools and replacement parts. Batteries were replaced with semisealed lead/acid marine batteries, dogs were welded on the clutch, and the switch gear was rebuilt and rewired so the electric mechanism was in working order. Linkages were repaired and greased, the wings were aligned, and the ballast tank was silver soldered. However, during the first trial run, acid leaked from the batteries, ruining much internal wiring. No replacement batteries suitable for the job could be found in the area, so electric power was not used. Packing Styrofoam was assembled in the sub to provide neutral buoyancy; however, at a depth of 50 feet, this Styrofoam compressed, decreasing buoyancy. An attempt was made to replace the Styrofoam with inflatable life jackets, but none were available.

Because of the poor condition of the sub and the unavailability of replacement parts, the mini sub was not used by the aquanauts for excursions. However, other swimmer delivery vehicles are available in many of the Navy facilities that could be very useful

for future programs. These could be readily adapted for use in the marine sciences mission. The vehicles should be capable of maintaining 3 to 5 knots for at least 4 hours. Recharging of the batteries should be easy to perform and facilites could be provided from the habitat for this purpose. Apparatus could be designed into each vehicle to hold aquanauts' research tools in a convenient manner to expedite their work, i.e., tools such as a clipboard and pencil, sonic tags, sonic receiver, geological equipment, etc. Swimmer delivery vehicles of the type briefly described here could provide a valuable service in the performance of the shallow-water saturation work.

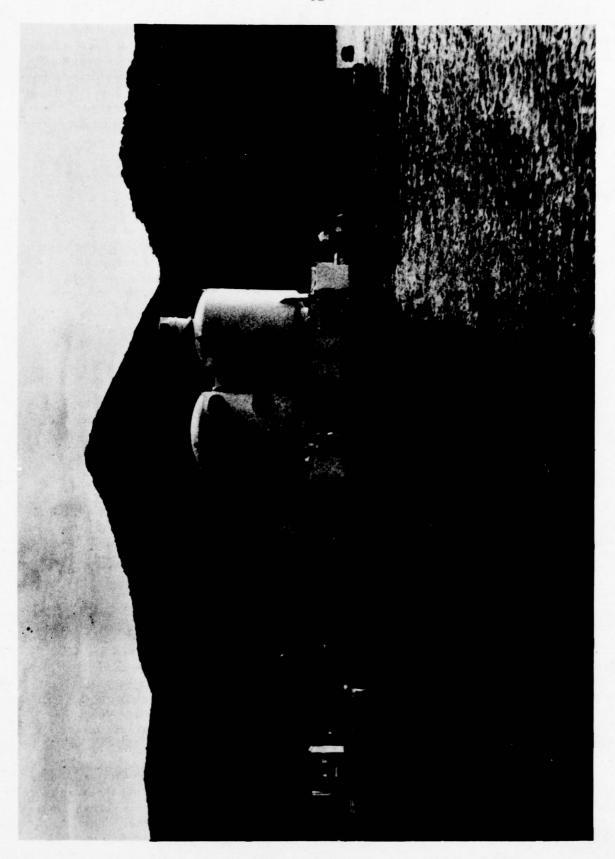
FIGURE 10, HABITAT AT LAUNCH SITE

The habitat, moored at the launch site, was being thoroughly checked and final housekeeping was being completed prior to lowering (Figure 10). At the same time, the Seabees were placing and adjusting a nonrigid template on the ocean bottom to act as a guide alignment for the piles. Considerable effort was expended aligning the template dimensions; extreme accuracy was needed to allow the barge to slide down the pilings for 30 feet when clearance between the piles and the hawse pipes was only 2 inches.

When finally the piles had been driven into the bottom, lowering away was held up to complete habitat systems' checks. All the while the seas were working the barge against the piling supports. After only a few days the piles fractured at a stress riser (hole) drilled in each pile to allow the water to fill the inside of each pipe. The piles were withdrawn, cut, rewelded, and reinstalled at a slightly different launch location.

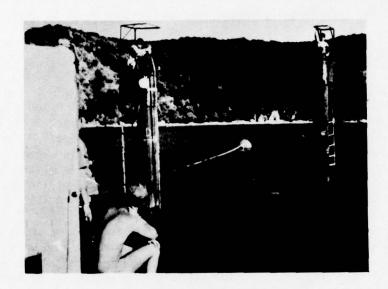
FIGURE 11. PILE TENDERS IN CROW'S NEST

Three attempts were made to sink the AMMI barge to the bottom. The procedure used was to station Seabees in crows' nests on top each pile controlling 5-kip winches to stabilize each corner of the barge independently as it lowered (Figure 11). Tensiometers in series with the winch cables indicated forces at each corner. Steel tapes, read simultaneously, precisely measured the barge horizontal attitude. The first lowering attempt was aborted because of darkness. On the second attempt, a corner pile pulled loose from the bottom a distance of 3 feet and had to be redriven. The barge was raised overnight because of time-consuming technical problems. The third attempt to launch the habitat went smoothly, with a minimum of operational difficulties; however it required a full day to complete. The floating habitat just after launch can be seen in Figure 12.

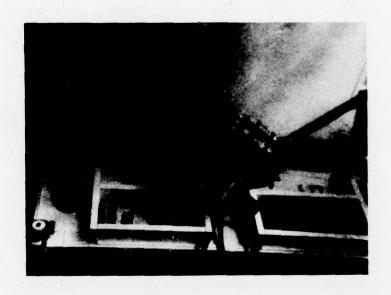
FIGURE 13. BALLASTING HABITAT USING TRAMMIE PIPE

the use of an AMMI barge becomes the most feasible method of habitat deployment. However, a more efficient method of habitat emplacement and ballasting could be incorporated. The use of electric downhaul winches would help with emplacement and a larger trammie pipe without joints would speed up ballasting.
